# Manhole Inspection Summary

Manhole # S51E\_\_018MH

Insp Date: **5/13/08 9:59 AM**

**Location** Address: **1 n streeper st**

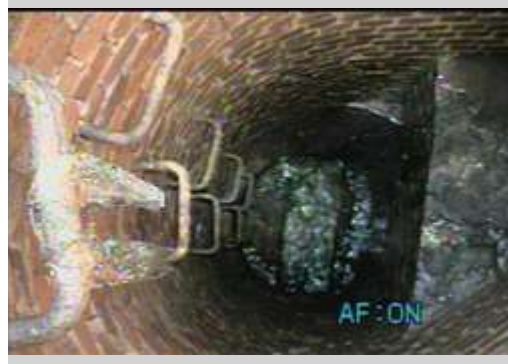
Top View

top view & steps

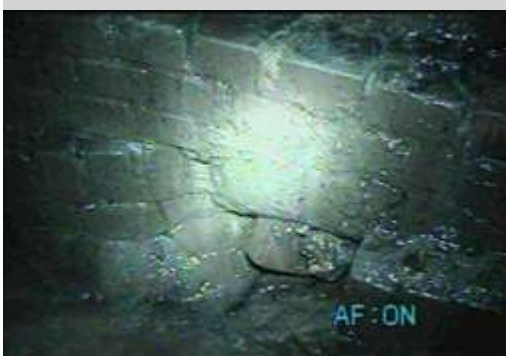
Defect 1

Condition: ☐ Sound ☒ **Cracked** ☐ Root Intrusion ☐ Deteriorated ☐ Leaks ☐ Debris

hole in channel

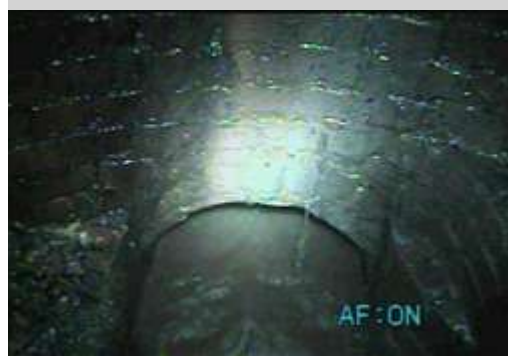
Defect 2

Infiltration: ☐ None ☐ Joint ☐ Cracks ☐ Mortar ☐ Roots ☒ **Wall**

Barrel infiltration

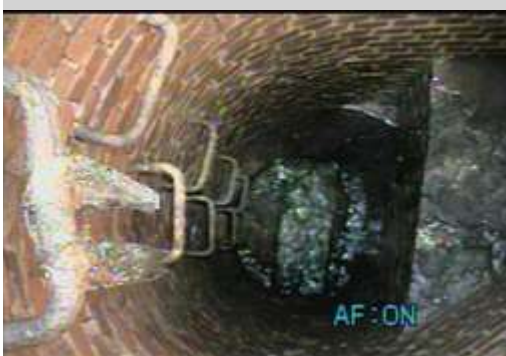
Defect 3

Count: **10** Missing: **0** ☒ **Corroded**

☒ **Evidence Of Surcharge** Depth: **2** (ft.) ☐ Active Surcharge Present

corroded steps, evidence of surcharge

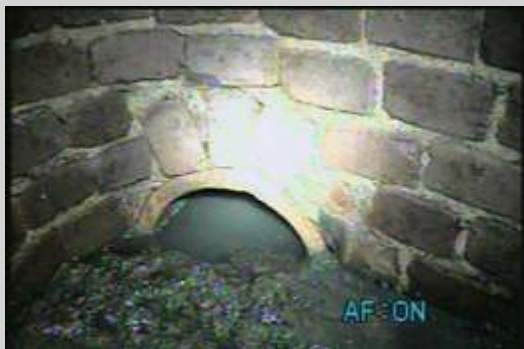
3 O'Clock Inflow

Deposits: ☐ None ☐ Mud ☐ Sludge ☒ **Debris** ☐ Grease

Silt Depth: 4 (in.) Deposits Extent: **Medium**
